Date of Crash 08/25/2020	Time of Crash 21:25 24HR	City/Town RANDOLPH	Motor Vehicle Crash Police Report	Number Vehicles 1	Number Injured 1	Speed Limit 35 Latitude _____ Longitude _____	State Police <input type="checkbox"/> Local Police <input type="checkbox"/> MBTA Police <input type="checkbox"/> Other: _____
-----------------------------	--------------------------------	-----------------------	--	----------------------	---------------------	---	--

Quincy Police Department Crash Reconstruction Report

Reconstructionist Assigned	Sgt. Stephen DesRoche
Case Number	20039482
Date	8/25/2020
Time	21:22
Location	501 N. Main St., Randolph, MA
Type of Crash	Pedestrian

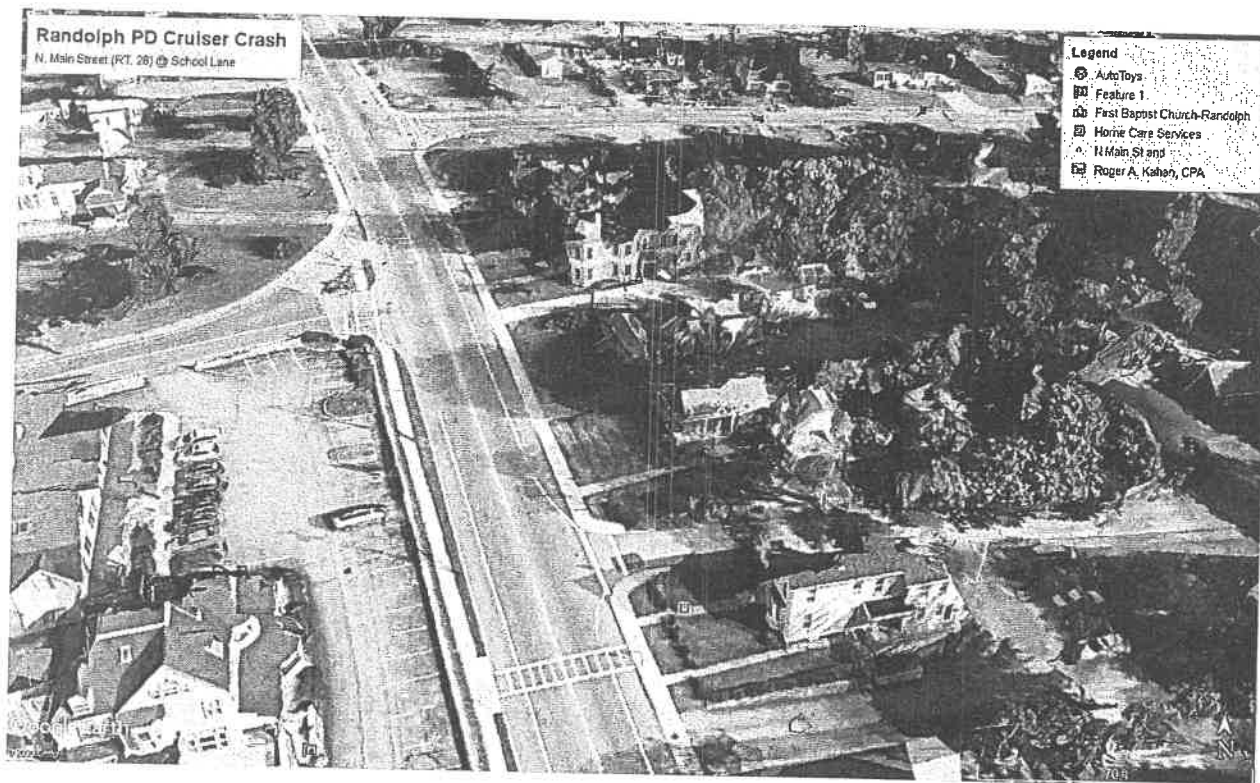
Figure 1

- 3.) At this time, Officer Downing, Officer Donnelly and I began to walk the scene to make our observations. I observed several items, objects and marks that I wanted to document and locate for evidence purposes. The vehicle involved in this crash (Randolph Police cruiser #737 MA Reg MP737R) was stopped with its emergency lights still activated in the breakdown lane of the southbound side of N. Main Street at the intersection of Grove Street. Upon further observation, I could see that the windshield of the cruiser was heavily damaged from the impact of the pedestrian, as well as, some damage to the front push bar (passenger side). I observed a skid mark on the ground leading from the vehicle's RF tire back on to the roadway potentially indicating when the operator (ELMAN) started to take corrective action and applied his brakes. Officer Donnelly and Officer Downing observed marks near the double yellow lines of possibly the location the pedestrian came into contact with the pavement after separating from the vehicle. I then continued to walk the scene and observed some paperwork on the ground belonging to DIVENS, as well as, a large area of broken glass (windshield) indicating to me that the area of impact was further back heading south. As part of any investigation, especially ones involving pedestrians, I look at traffic signal functions and to check if they were operating properly with no defects. This area of N. Main Street (RT.28) had no traffic control devices except for 'Stop' signs for roadways entering N. Main

Street (Grove Street) and pedestrian crosswalks marked clearly at Grove Street, School Lane and on N. Main Street just south of School Lane. (See figure 1)

N. Main Street (RT.28) runs roughly north-south and has one (1) marked lane in each direction including a marked breakdown lane. The road is divided by a double yellow line lane marker and is constructed of bituminous asphalt material with raised sidewalks and curbing on both sides. The area of this crash is a heavily travelled state road with vehicular traffic even for this time of the day. The area was lit with street lighting but the ambient source did not seem to illuminate this area very well. (See figure 2) All streets mentioned in this report are public ways and are maintained either by the Town of Randolph or the Commonwealth of Massachusetts (MassDOT).

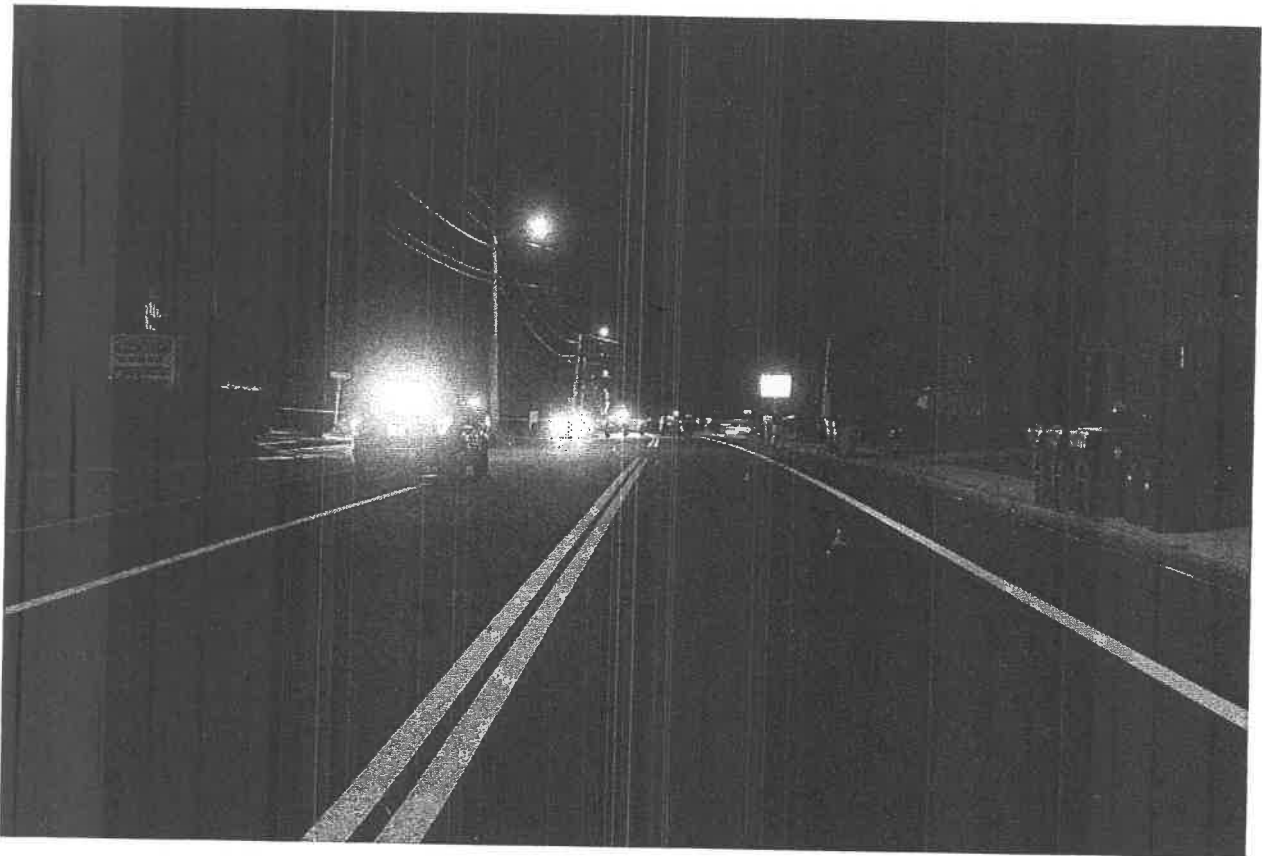
Figure 2

Through this investigation, I looked at the environment and layout of the roadway to ascertain the point of perception for both the pedestrian (DIVENS) and operator (ELMAN). Measurements taken show that DIVENS had a clear and unimpeded view of the northbound traffic flow (direction that Officer Elman was travelling) and that this view was approximately 1034 ft +/- or 2/10 of a mile. Along with this distance of perception, evidence shows that Officer Elman was responding to a 911 call for a domestic disturbance with his emergency lights and siren activated (Priority 1) on his cruiser which should have further made DIVENS

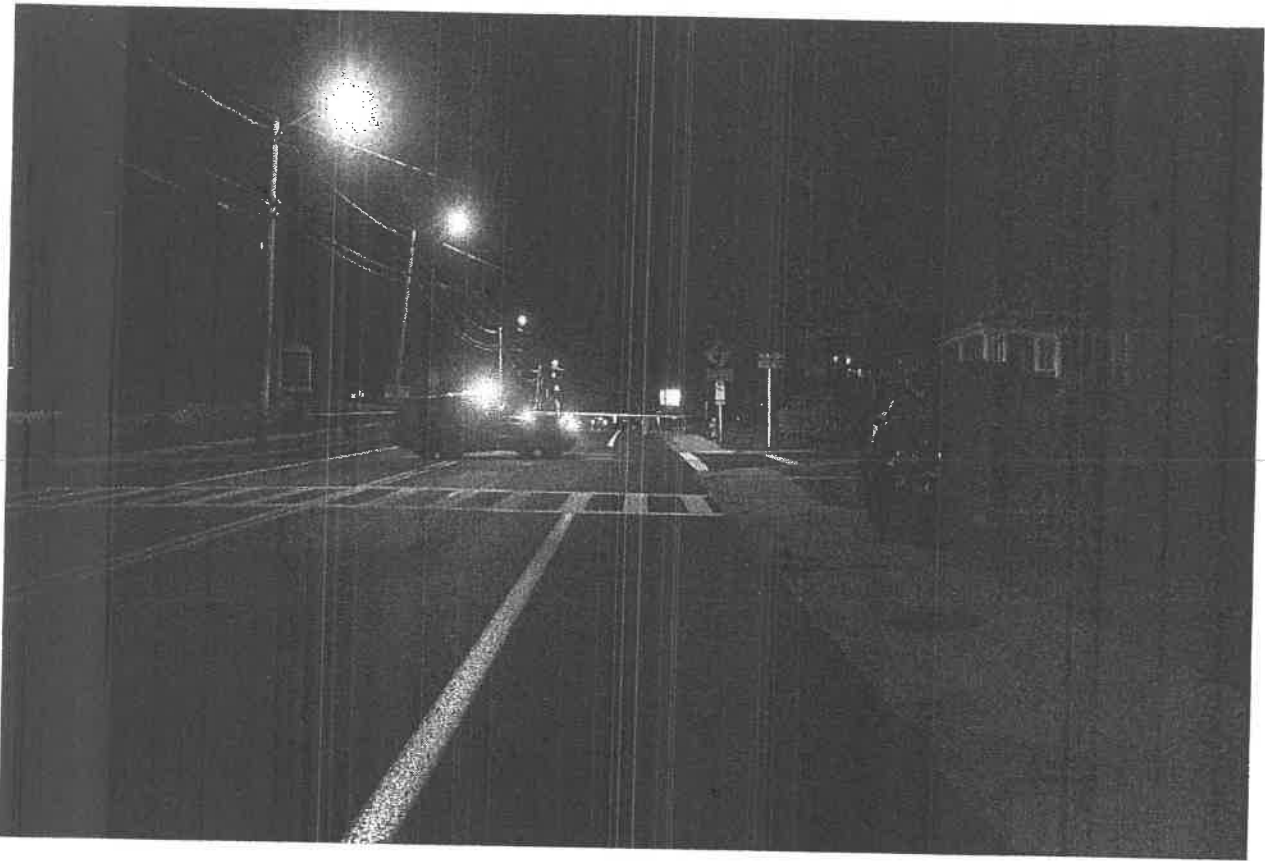
Figure 3

aware of his location and quick approach. Looking at the roadway markings, there was a fully marked out crosswalk at School Lane indicating the location that DIVENS should have crossed N. Main Street (see figure 3).

This crosswalk is approximately 135'-11" from the beginning area of the POI and 170'-0" to the end of this POI area. Officer Elman was travelling northbound on N. Main Street (RT.28) when he observed DIVENS in his travelled pathway of the roadway. Officer Elman immediately attempted corrective action by braking (hard due to skid marks) and steering to the left in an attempt to avoid hitting DIVENS. Due to the limited lighting, the glare of his emergency lights and the fact DIVENS presented in the roadway as a unlit object, this crash was unavoidable and further resulted in non-fatal injuries to DIVENS due to the quick and decisive actions made by Officer Elman that evening. In regards to the lighting, night driving is generally accepted to be two to three times more hazardous than daylight driving per mile driven. This leads to a safety and human factors concern, because there are a variety of nighttime driving limitations that reduce the ability to detect and recognize objects when compared to daytime driving. Driving is a task that mainly depends on the driver's visual system. Visual perception problems arise at night for a number of reasons. Major visual functions such as acuity, contrast sensitivity, and depth perception are reduced substantially at lower illumination levels. The glare of opposing headlights can also reduce the visibility of low contrast objects such as pedestrians.
